Manhole Inspection Summary

Manhole # S23QQ1006MH

Location Address: **4712 FALLS RD**

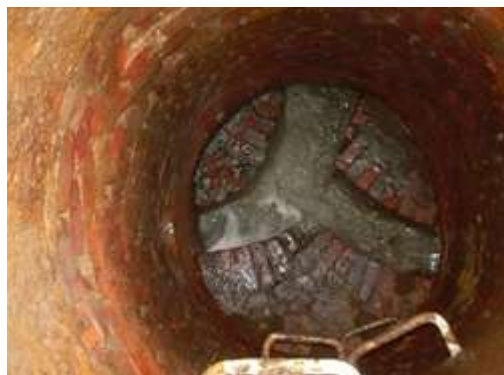
Top View

Bench debris.

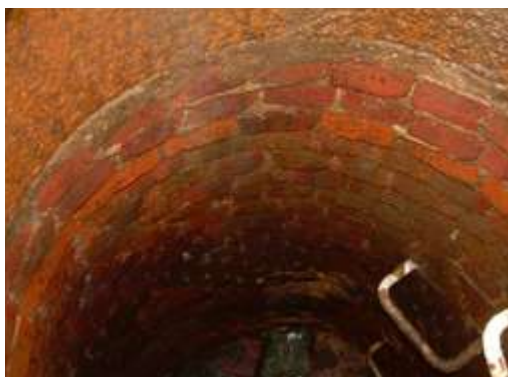
Defect

Frame Offset: **0** (in.) Condition: ☐ Sound ☐ Cracked ☒ **Leaks**

Infiltration: ☐ None ☒ **Joint** ☐ Cracks ☐ Mortar ☐ Roots ☒ **Wall**

Condition: ☐ Sound ☐ Cracked ☐ Root Intrusion ☐ Loose Brick ☒ **Deteriorated**

Infiltration: ☐ None ☐ Joint ☐ Cracks ☒ **Mortar** ☐ Roots ☒ **Wall**

Frame leaks. Corbel and Barrel infiltration.

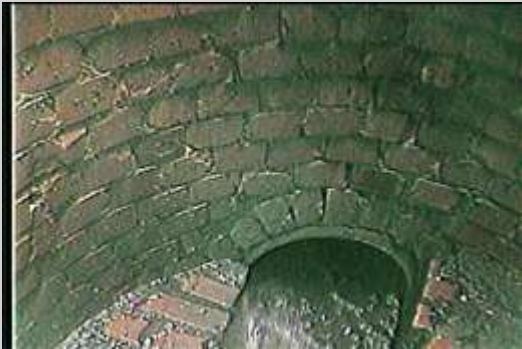
15 in. Circular Gravity Sewer Pipe Out @ 12 O'Clock

Infiltration: **Evidence** Pipe Seal Cond: **Cracked**

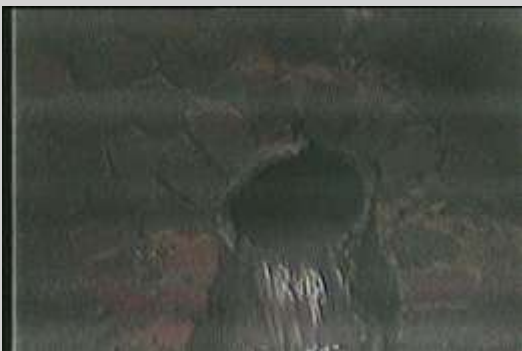
8 in. Circular Gravity Sewer Pipe In @ 3 O'Clock

Infiltration: **Evidence** Pipe Seal Cond: **Broken**

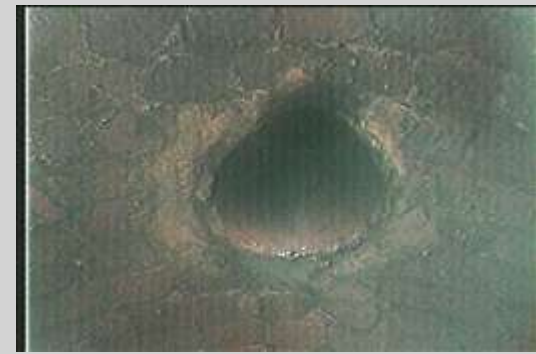
Pipe In @ 9 O'Clock

Infiltration: **Evidence** Pipe Seal Cond: **Broken**
